Faller dies when struck by bucked tree

Notice of Incident information

Number: 2008161750006

Core activity: Manual falling and bucking

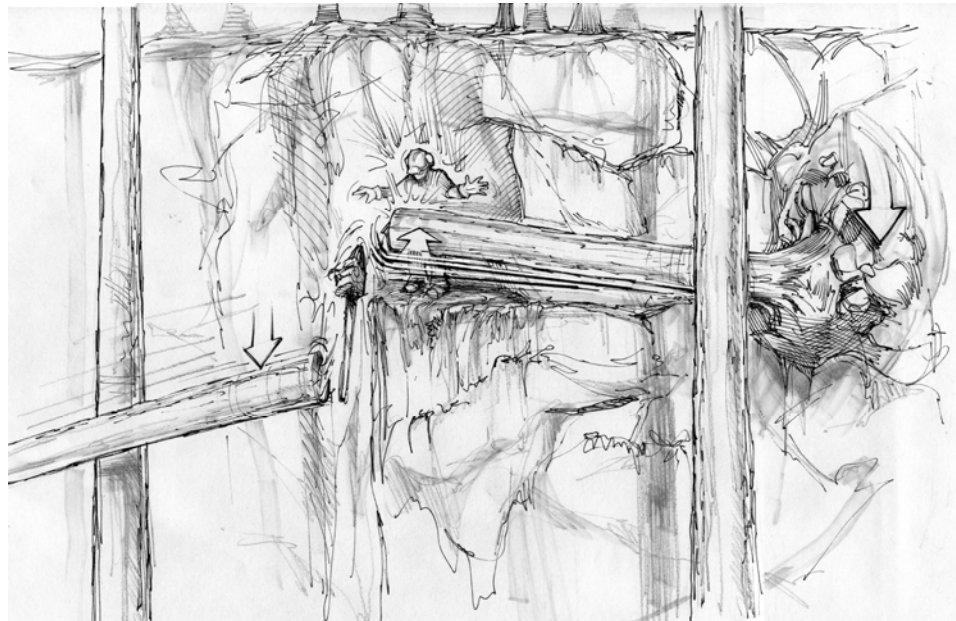
A faller was standing on the narrow ledge of a cliff to buck a windfall tree. The windfall's rootwad was lying on the perimeter of the ledge and was only loosely attached to the ground. Most of the windfall's 58-foot trunk was suspended between two standing trees below the ledge. As the faller completed the bucking cuts, the rootwad rolled downhill off the ledge, causing the lower part of the trunk to pivot on one of the standing trees. Then as the suspended trunk swung uphill, its bucked end pinned the faller against the cliff. He sustained fatal injuries.

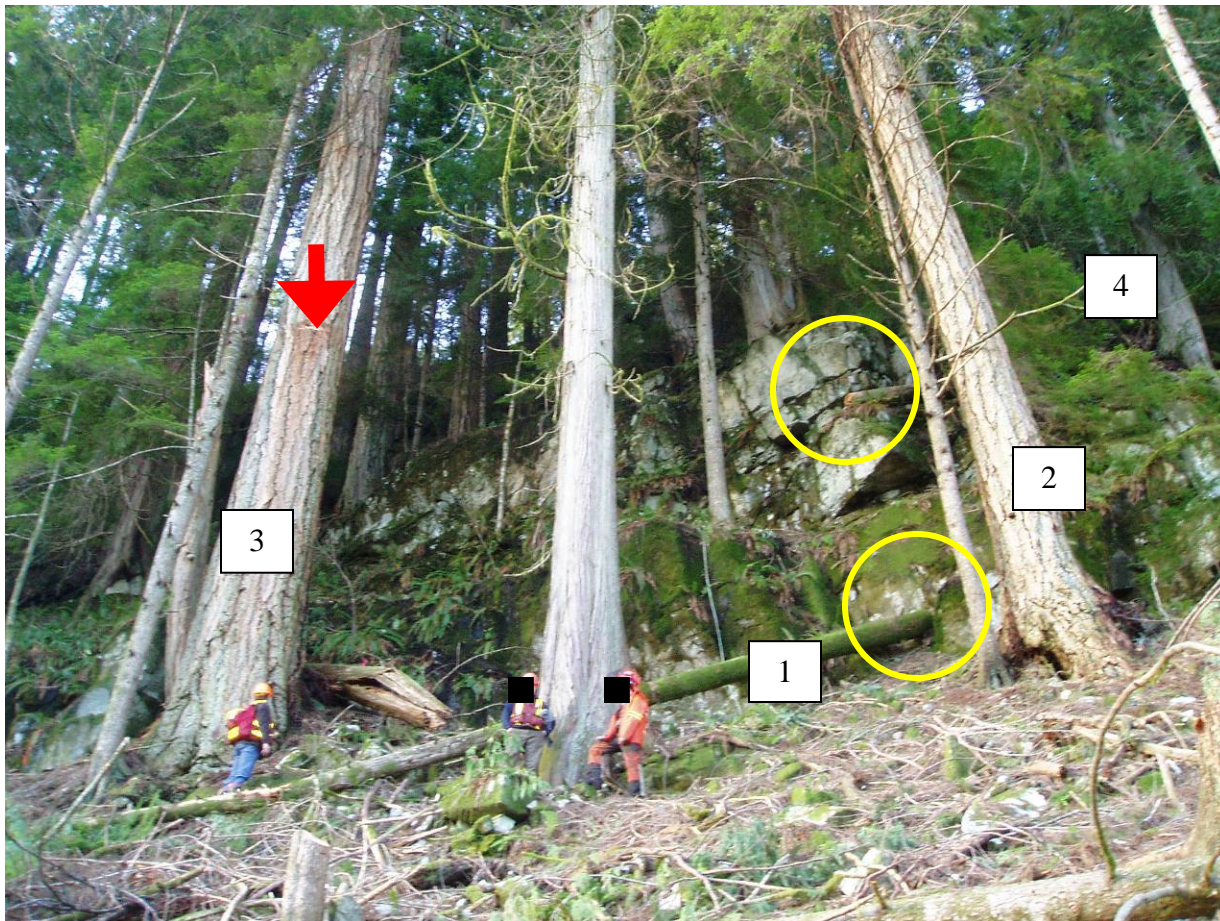
Figure 1: Incident area, showing the rocky ridge with its cliff ledge. The bucked ends of the blown-down tree (1) are circled. The red cedar tree (2) is at the bottom of the cliff. The red arrow points to the rub mark on the fir tree (3) made by the top of the blown-down tree. The original location of the blown-down tree's rootwad (4) was near the edge of the cliff ledge. (Photo courtesy of International Forest Products Ltd.)

Before the incident, the blown-down tree's rootwad was at the edge of the cliff ledge, only loosely attached to the rocky ground by a few roots. It had plenty of rocks embedded in its dead root system.

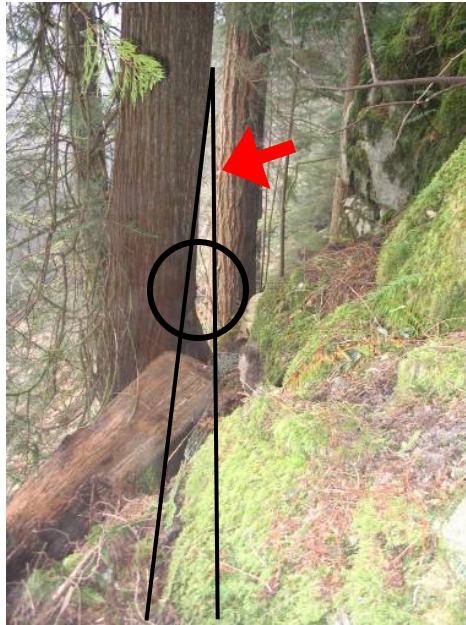
The lower third — that is, the end with the rootwad attached — of the 58-foot blown-down tree was positioned over the narrow end of the cliff ledge. This portion was wedged against the uphill side of the red cedar. The suspended upper two-thirds of the blown-down tree extended out from the cliff ledge into the logging block below. The broken top of the blown-down tree was wedged against the downhill side of a fir tree (see Figure 2).

Figure 2: *Narrow end of the cliff ledge. The blown-down tree, as depicted by the vertical lines, was suspended between the two large standing trees. The arrow and the circled area show where the suspended blown-down tree contacted the standing trees. Rub marks on the standing trees were evident at these contact areas. The blown-down tree's pivot point was inside the circled area.*

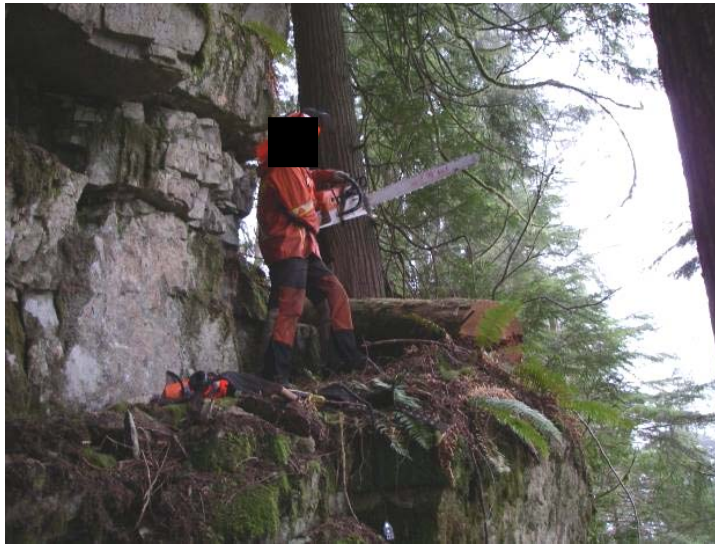
No one witnessed the incident, but evidence at the scene indicates that Faller 1 bucked the blown-down tree about 20 feet from the rootwad. Faller 1’s injuries and the undamaged condition of his saw indicate that he operated the saw with his right hand and with the saw held to his right. He made the bucking cut while standing on the wider end of the ledge (see Figure 3). The tree had a 16-inch diameter where Faller 1 placed his bucking cuts, and it was suspended over the ledge at a level just below Faller 1’s chest.

Figure 3: Depiction of Faller 1’s position at the wide end of the cliff ledge.

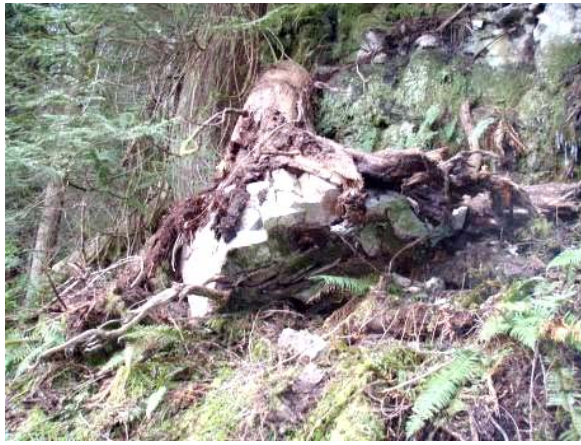
Figure 4: *The rootwad came to rest below the ledge after Faller 2 made his bucking cut to release Faller 1. Note the rocks embedded in the rootwad.*

The rootwad lay on the edge of the sloping cliff ledge with only a few of its small roots still in the ground. Many rocks embedded in the rootwad made it extremely heavy (see Figure 4). Its weight contributed to its sudden fall downhill and the tree's sudden pivoting. The weight of the falling rootwad forced the rest of the tree to pivot uphill toward the cliff face.

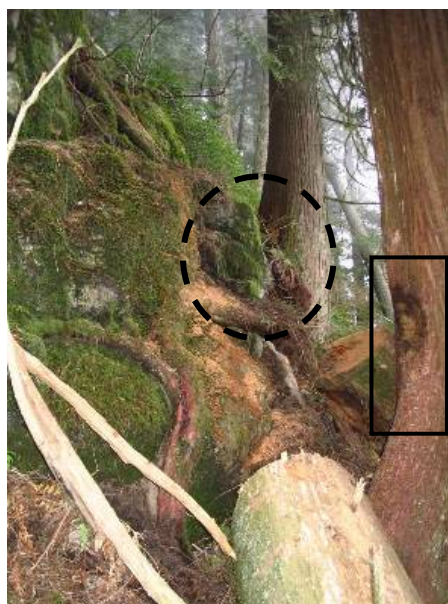
The cliff ledge at the pivot point was narrow and uneven, and it sloped significantly. It is possible that Faller 1 felt that it was safer to buck past the pivot point on wider and flatter ground than to buck it at the pivot location. Faller 1 did not buck from his off-side; instead he stood behind the bucking area, which suggests that he did not anticipate that the tree would spring toward him (see Figure 5).

Figure 5: *Pivot point on standing tree shown inside the circle. The rub mark from the blown-down tree appears in the square. The rootwad originally lay behind the rock outcropping, next to the standing tree in the circled area.*
